Accelerated Life Cycle Comparison of Millenniata Archival DVD

**Ivan Svrcek
Life Cycle and Environmental Engineering Branch
Naval Air Warfare Center Weapons Division
1900N. Knox Road
China Lake, CA 93555**

Final Report for Millenniata DVD Testing August 2009 - October 2009.

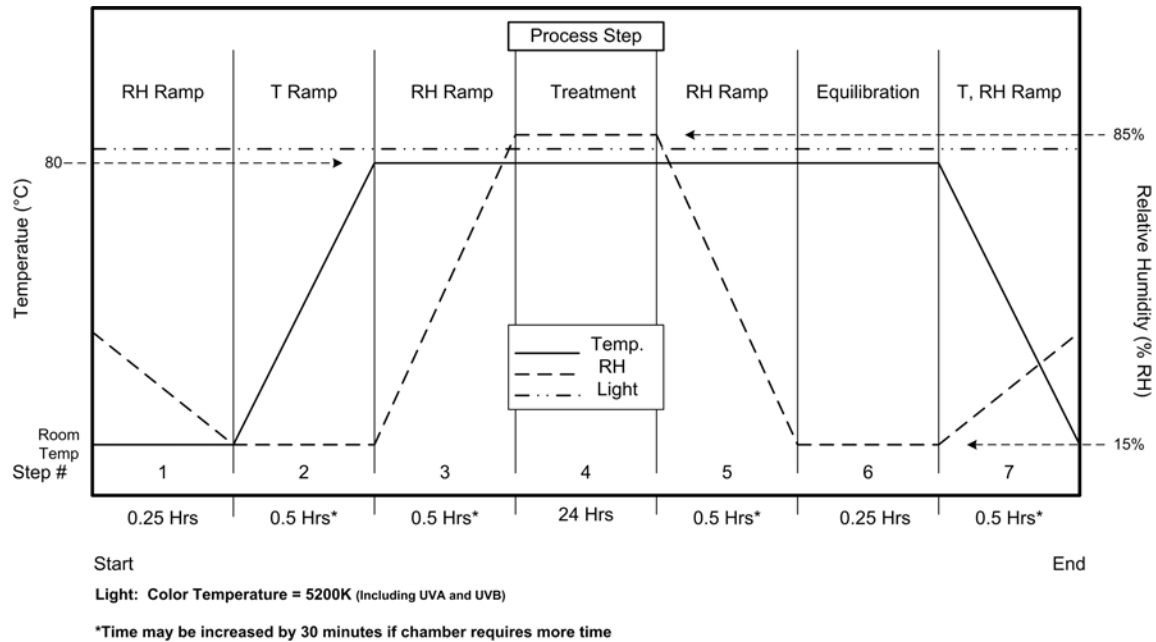
Figure 1-1. Millenniata Test Plan Stress Cycle

The stress test is a single combined temperature, humidity and light cycle. This cycle is composed of a ramp up, a 24 hour dwell, a ramp down and an equilibration period that is conducted with illumination throughout the cycle. Figure 1-1 depicts this cycle.

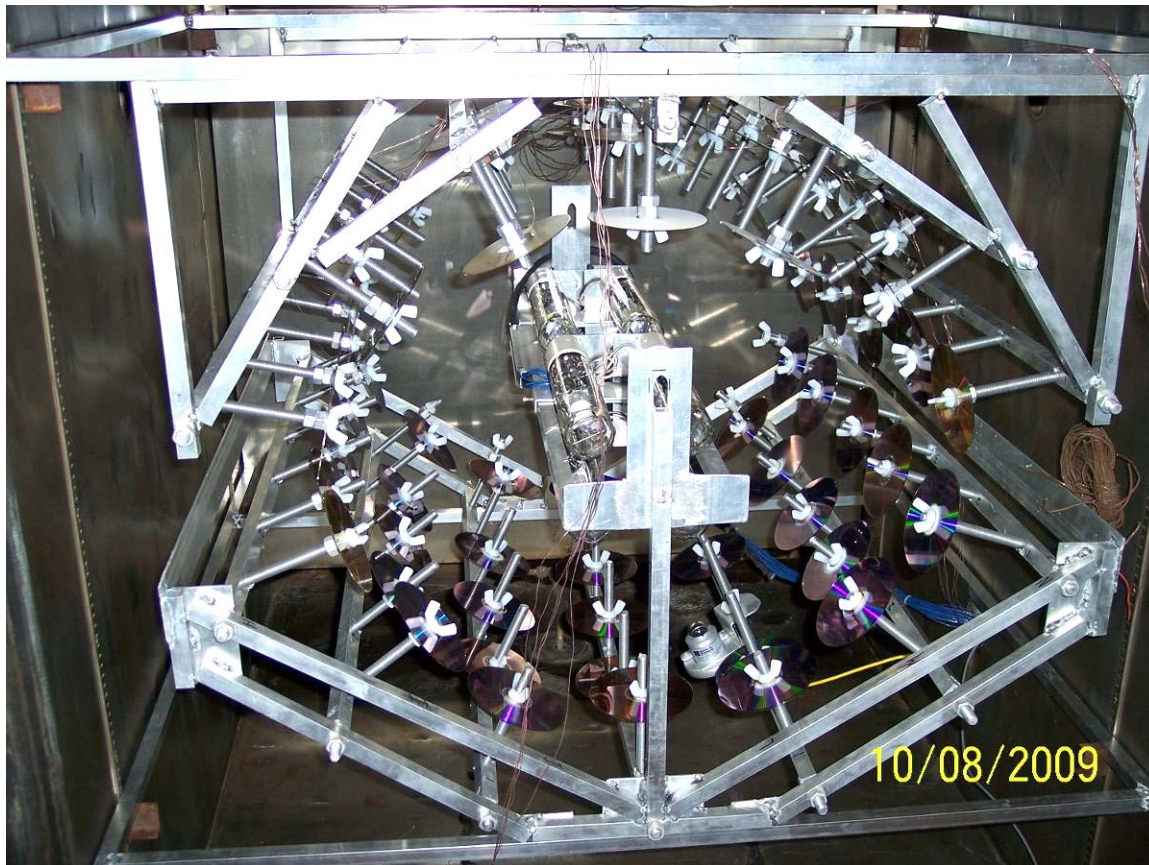
Figure 2-1. Disc Exposure Rack in Chamber

The assembly fabricated to meet this need was designed for use in a Thermotron SE-1200L. The SE-1200L was found to have insufficient cooling and humidity generation capability for the test, so the fixture was modified for use in a Sexton Espec altitude chamber which had been retrofitted with a Thermotron 8800 controller. The assembly as it sits in the Sexton Espec chamber is shown in Figure 2-1.

This rig uses eight lamps to produce 3.2kW of light and expose 50 DVDs to irradiance levels in the range of direct sunlight (1120 W/m^2). The setup is composed of four main sections: a ballast box, a light array, an upper rack and a lower rack.

This array, as Figure 2-1 shows, is mounted horizontally between the two racks. It is supported by the lower rack and is adjustable in the vertical axis to allow positioning equidistant from the upper and lower racks. A more detailed view of the light bar is shown in Figure 2-4.

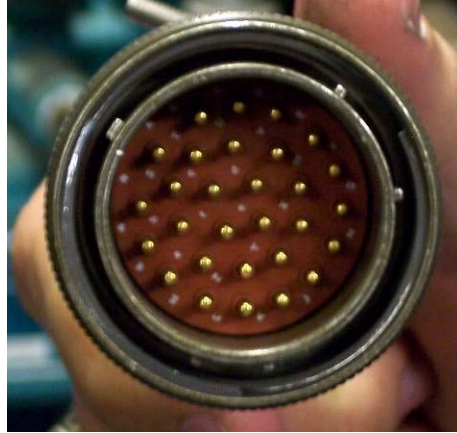
Figure 2-3. Wiring Harness Connector

The ballast box is located outside of the chamber and is connected to the lamp array by a 10 foot long wiring harness with a multi-pin connector. This connector, shown in Figure 2-3, fits in the pass through holes on the chamber allowing easy placement and removal of the light array.

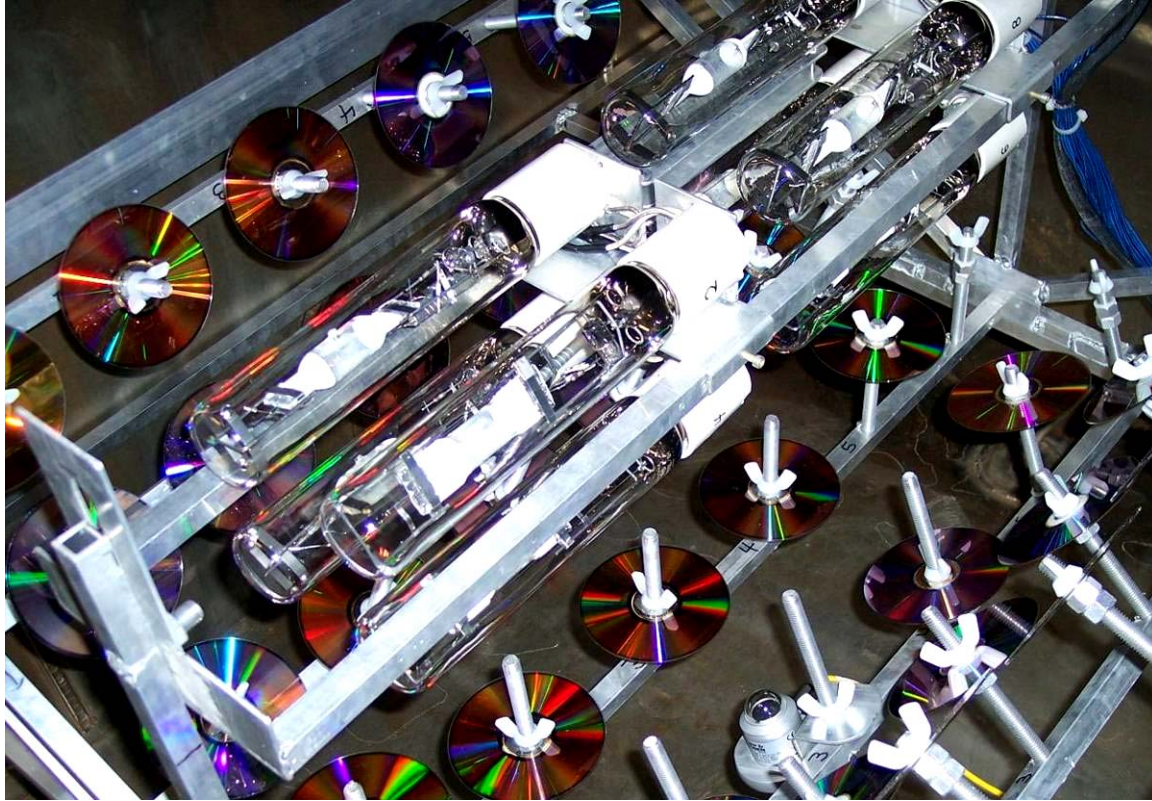
Figure 2-4. Lamp Array Detail

This photograph shows the front cluster of four bulbs. There is a front and rear set, both of which can be moved independently along the central axis of the setup. This allows the radiation pattern to be adjusted for uniformity along the depth of the racks.

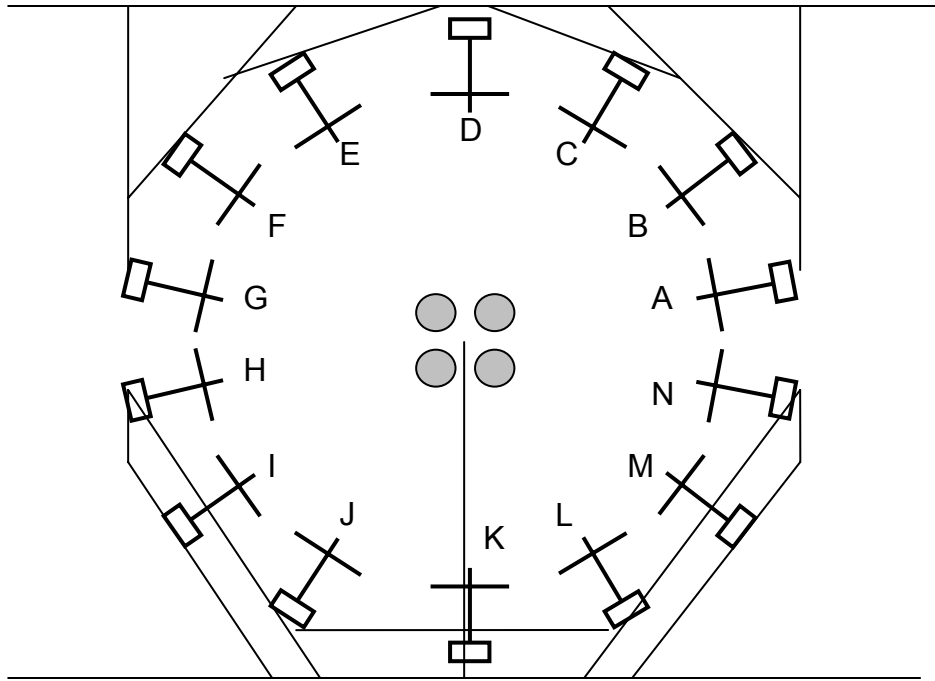
Figure 2-6. Chamber Layout Front View

The racks include a numbering system. Figure 2-6 depicts the fixture as it would appear looking through the chamber door showing the alphabetic row designation used. The upper 7 rows are labeled A through G and the lower 7 rows are labeled H through N in counterclockwise order.

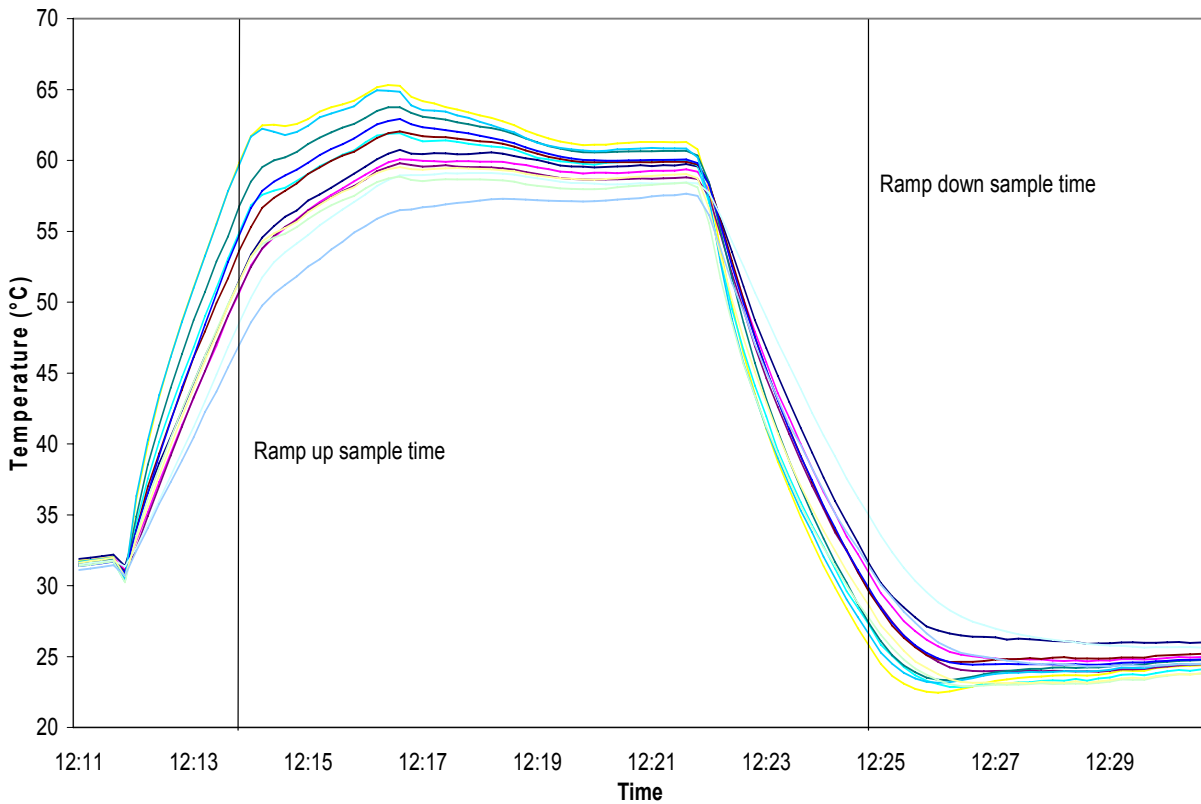
Figure 2-8. Representative Ramp Cycle for Airflow Measurement

Initially, disc temperatures within the chamber varied by more than 10°C. To remedy this various scoops and baffles were tested. Because full temperature tests with lights would have taken over 2 hours, they were not a viable option for trying new arrangements. Instead, as a first check, an anemometer was used to measure airspeeds in various areas. Once an arrangement was deemed to be worth testing further, the chamber was quickly ramped up to 60°C and back down as shown in Figure 2-8.

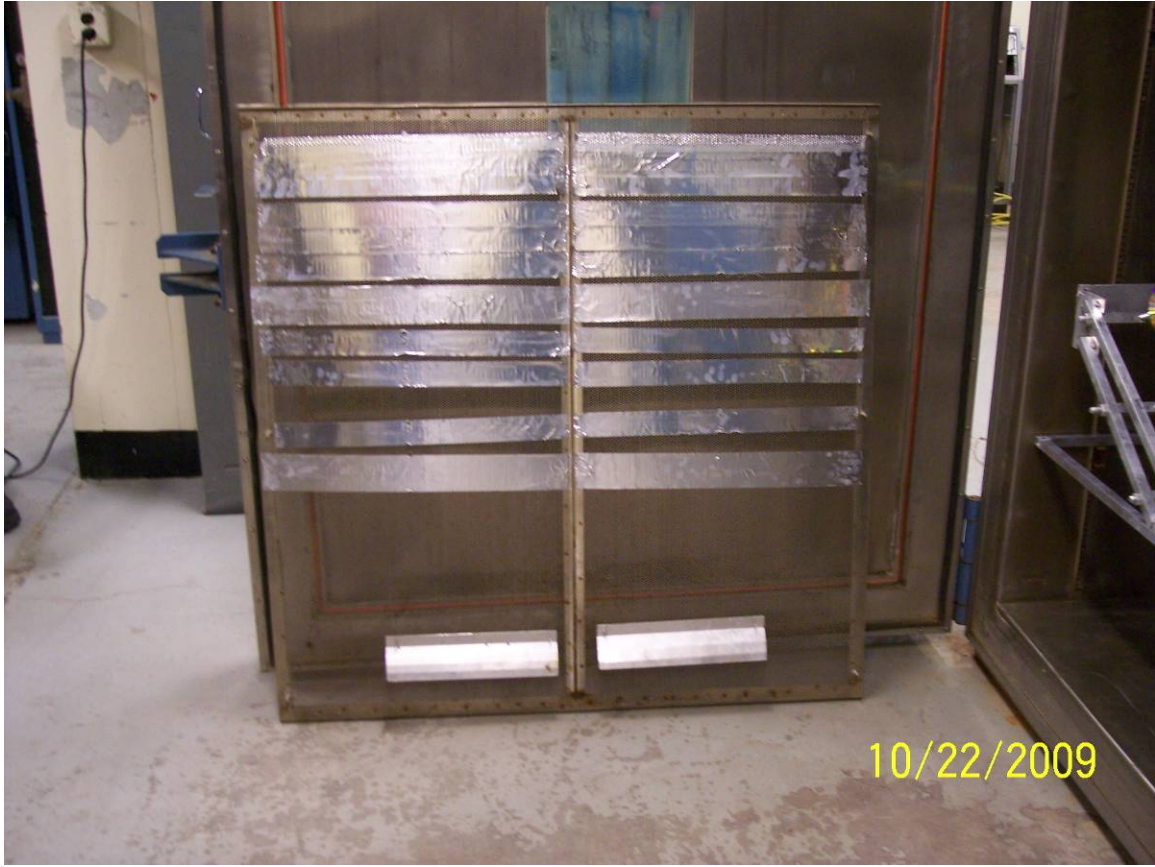
Figure 2-10. Airflow Redirection Solution

When these graphs exhibited a significant improvement over previous attempts, the chamber was run up to temperature with lights and humidity to check the actual temperatures. The end result of this tweaking process was two scoops located on the chamber fan screen $3\frac{1}{2}$ " from the rear and a large amount of aluminum tape on the end nearest the door. Figure 2-10 below shows the fan screen as it was used in the test.

After 2 ½ days of airflow adjustment, this combination was judged to be the most effective solution with a temperature spread in the 5°C range. This range may have been improved marginally by further testing, but it was felt that the results were reasonable for this test and the effort would be better spent elsewhere.

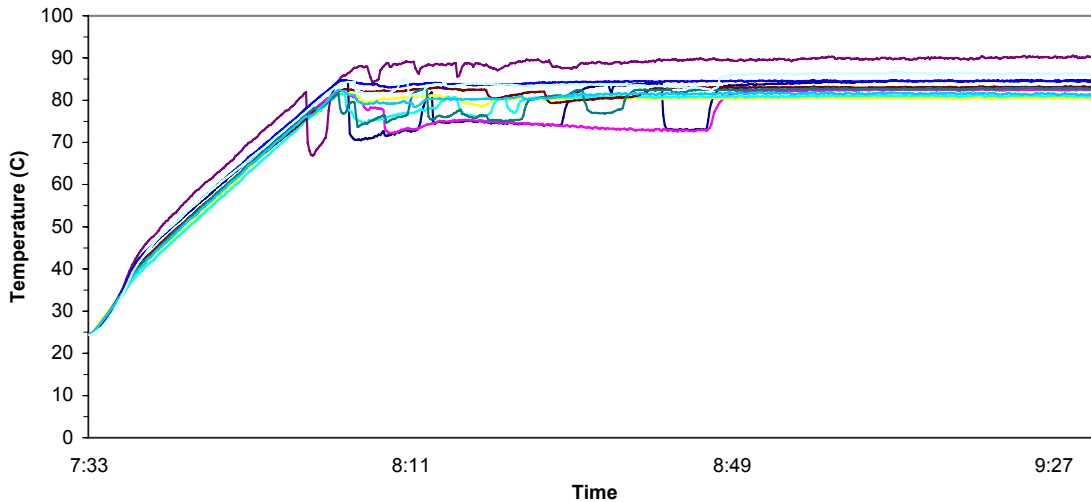
Figure 2-11. Temperature Ramp Showing Condensation

spots on the surface of the DVDs in the chamber. The second was a large variation in the disc temperature readings during ramp up and the start of dwell. Figure 2-11 demonstrates the observed temperature variations. The lower limit of the temperature swings corresponded to the wet bulb temperature for the current humidity and temperature conditions.

To alleviate this condensation issue, the ramp up profile was changed from the initial 30 minute temperature ramp and 30 minute humidity ramp to a 30 minute temperature ramp with a 45 minute humidity ramp.

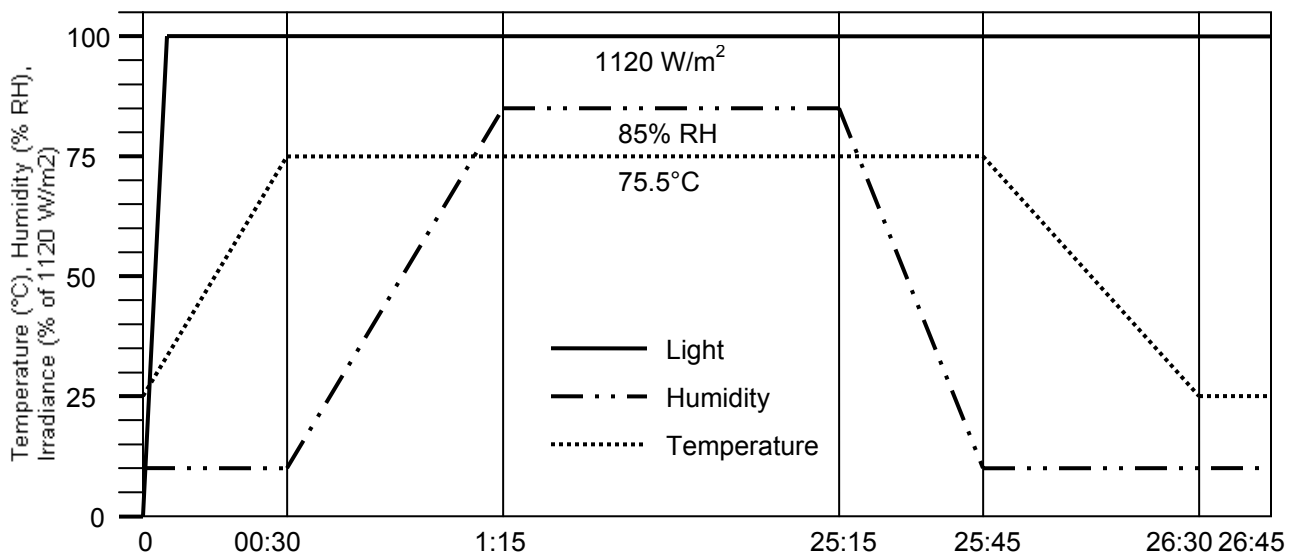
Figure 2-12. Chamber Stress Cycle Program

After checking with Millenniata this stress cycle was used for all three test runs.

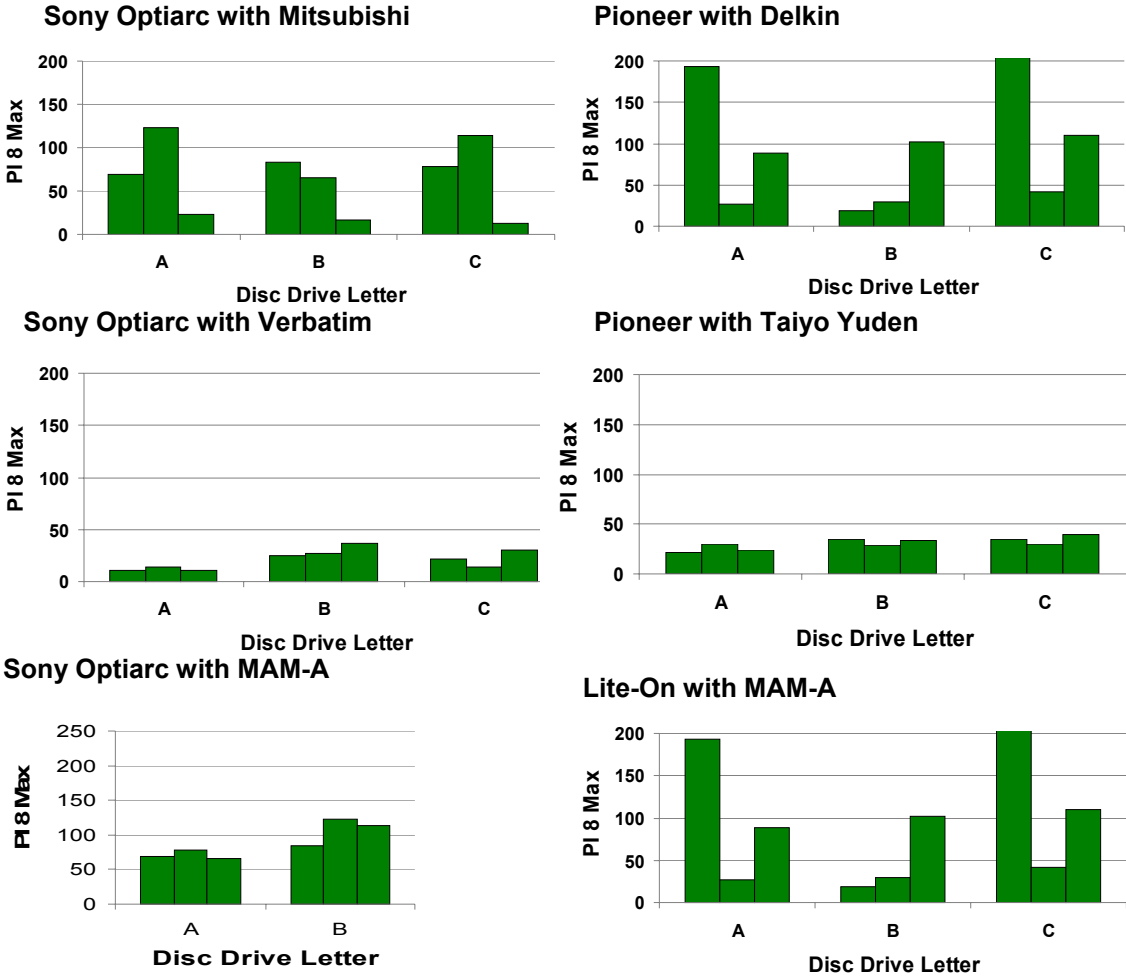
Figure 3-2. Within Manufacturer Drive Comparison

All three drives from each manufacturer used were characterized to determine if they could all be used for burning. The decision based upon this information in Figure 3-2 was that all drives were suitable for use except for the Lite-On B and C drives.

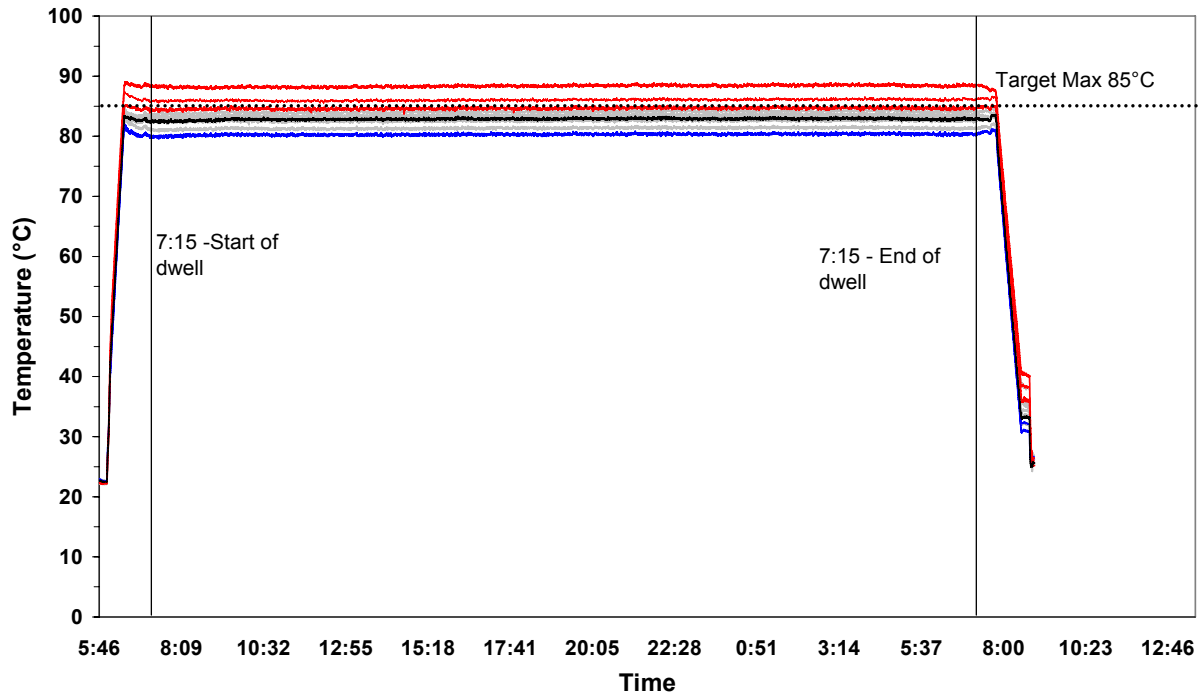
Figure 3-5. October 18-19 Disc Temperatures

The disc temperatures during dwell were, like the ramp conditions, close for all three runs. Figure 3-5 demonstrates the constant dwell temperatures seen in the first run. The graphs of the other runs are included in Appendix B.

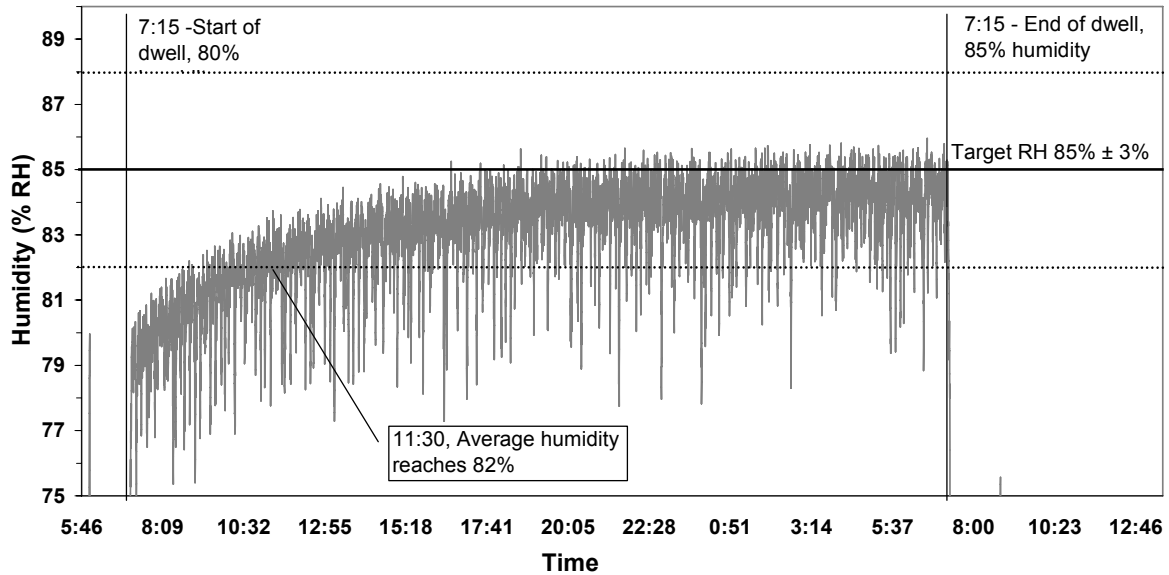
Figure 3-7. October 18-19 Humidity

An average humidity graph is not shown because, unlike the disc temperatures, the humidity did not reach equilibrium by the beginning of the dwell period. Figure 3-7 shows the humidity during the first run. It demonstrates the same trends as the graphs for the 2nd and 3rd runs included in Appendix B.

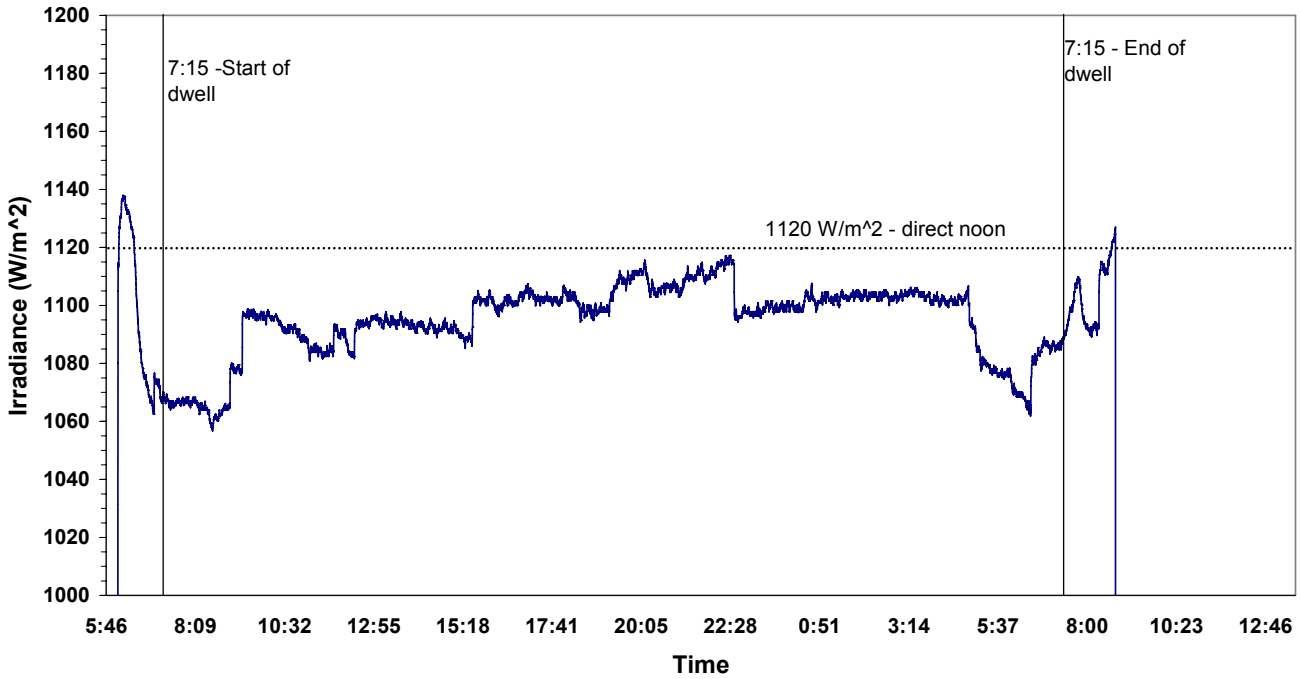
Figure 3-8. October 18-19 Irradiance

While the temperature and humidity data was very similar for each cycle, the irradiance data demonstrates differences. One element that was present in all three cases was the irradiance reading shooting up to a peak quickly during the temperature ramp up and then dropping down below the target irradiance before the start of the dwell period. Figure 3-8 shows this for the first test run.

This peak and then drop is likely due to the effects of the temperature ramp upon the sensor. Likewise, the average irradiance at dwell is likely different from the irradiance measured at room temperature due to a temperature dependence of the CMP3. What is important to note, and can be seen in Figure 3-9 and Figure 3-10 as well, is that the irradiance levels appeared to vary during each test as much as $\pm 30 \text{ W/m}^2$. While this data was taken at the edge of the pyranometer temperature range and may not be an accurate representation of the actual conditions, it indicates that the irradiance levels were not maintained within the Millenniata boundaries of 1075 W/m^2 and 1165 W/m^2 .

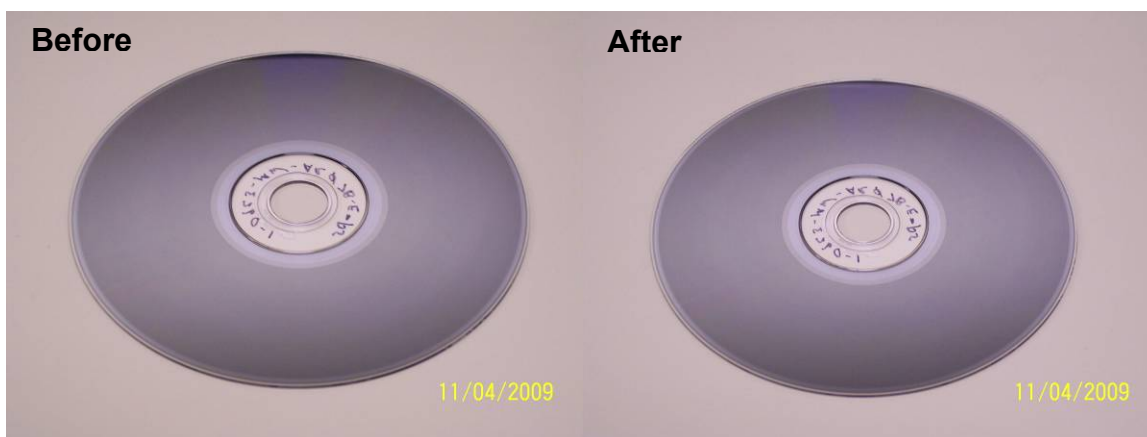
Figure 3-13. Millenniata Before and After Pictures

None of the Millenniata discs experienced any visible change during the test.

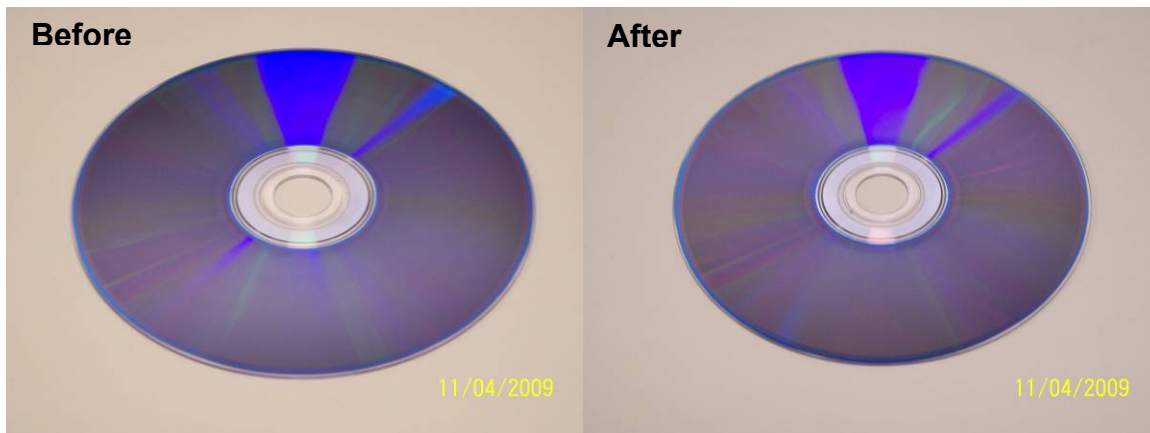
Figure 3-15. Taiyo Yuden Before and After Pictures

The Taiyo Yuden disks were visibly the least affected of the dye based media. Most discs failed to exhibit any perceptible difference.

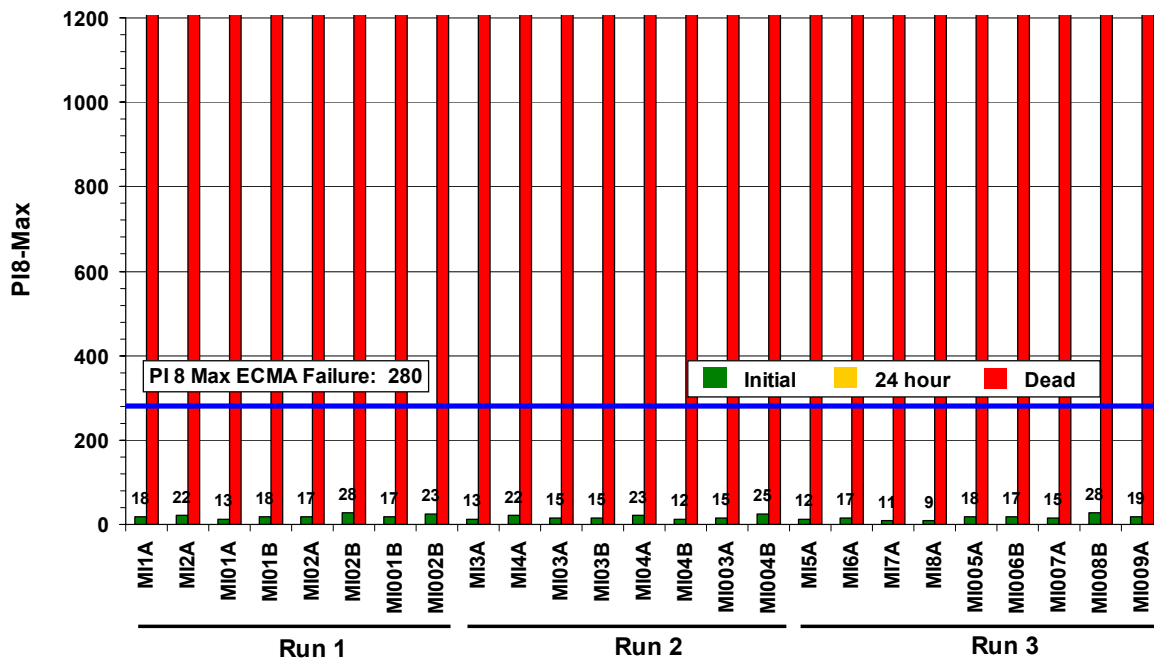
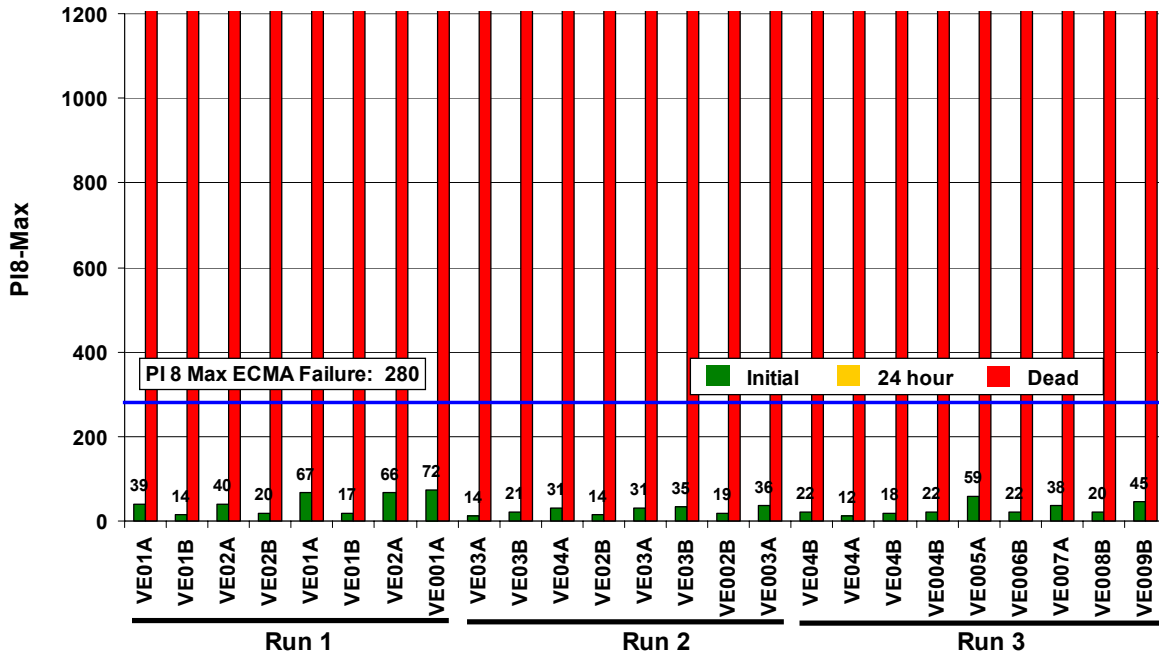
The discs which sustained the heaviest visible damage, the Mitsubishi and Verbatim, all failed to be read by the analyzer. Many of the discs were not recognized at all by the drive. Those that were recognized and started to run quickly dropped down to read speeds approaching zero and eventually terminated unsuccessfully. Figure 3-17 and Figure 3-18 show combined baseline and post stress P18 max graphs for the Mitsubishi and Verbatim discs.
